Inspection Report

Property Address:
9907 Summit Ave NE
Rockford MI 49341

Key Home Inspections, LLC

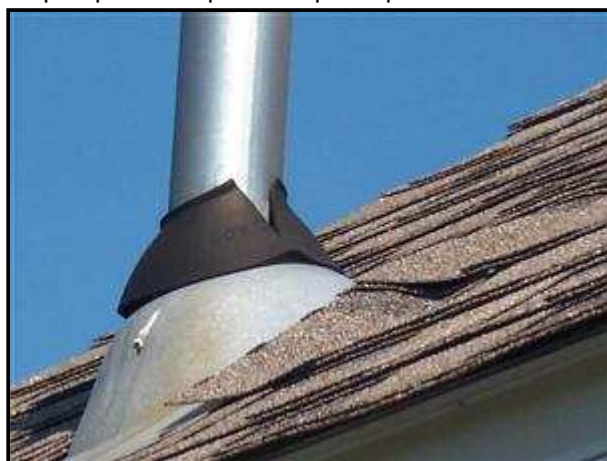
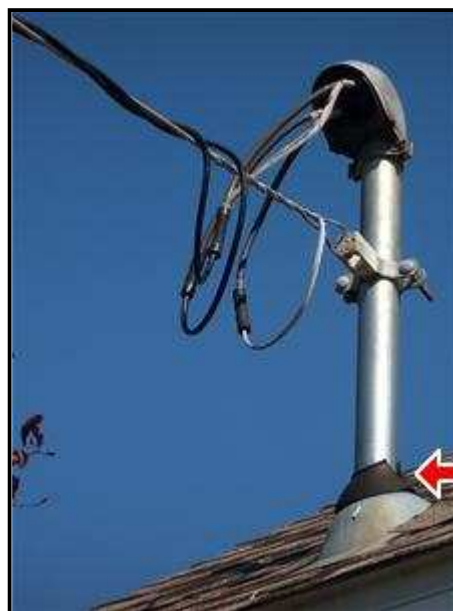
1.2 Picture 1

1.2 Roof penetration boot has failed (cracked or come loose). This condition can cause leaking or rot. Suggest a qualified repair person repair or replace penetration seal.

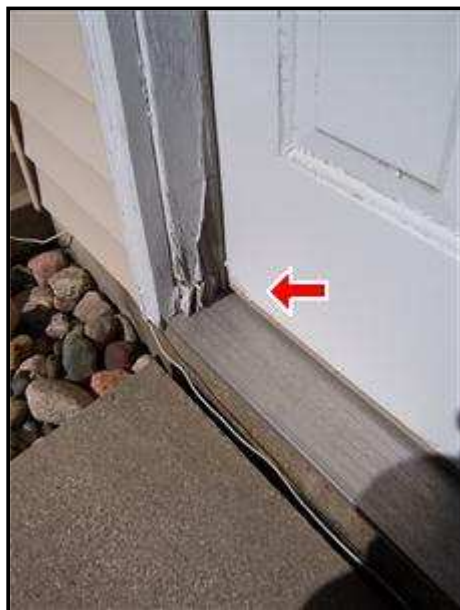
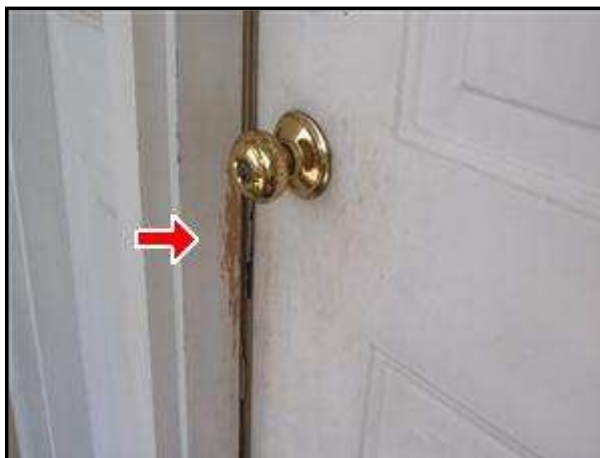
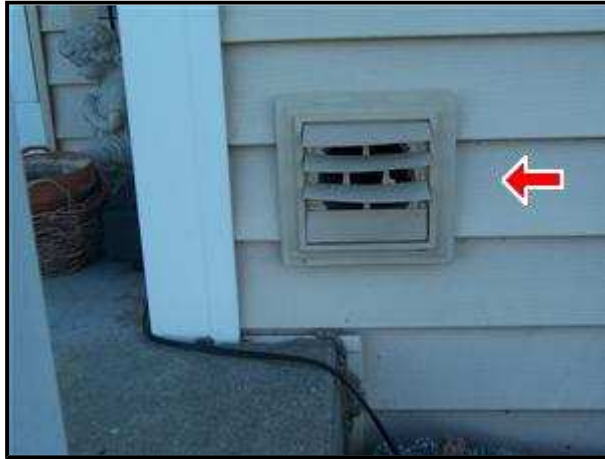
2.1 Picture 1

2.1 The rear entry door to garage has deterioration at lower frame. This should be repaired or replaced to prevent further deterioration and rot.

Seal at front door is deteriorating and needs repair or replacement.

Dryer vent at exterior of home is stuck open. This can allow vermin and debris to accumulate in dryer vent. This potentially can clog vent causing an unsafe condition.

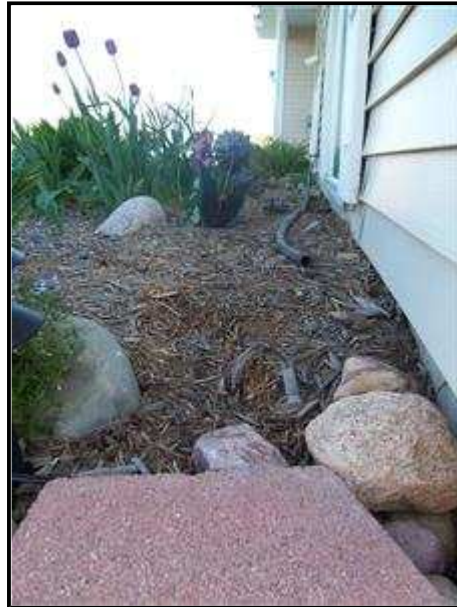
2.4 Picture 1

2.4 The landscape at the front of home may require a trench or drain if water stands or puddles after heavy rain. I am unable to determine due to no rain during inspection period.

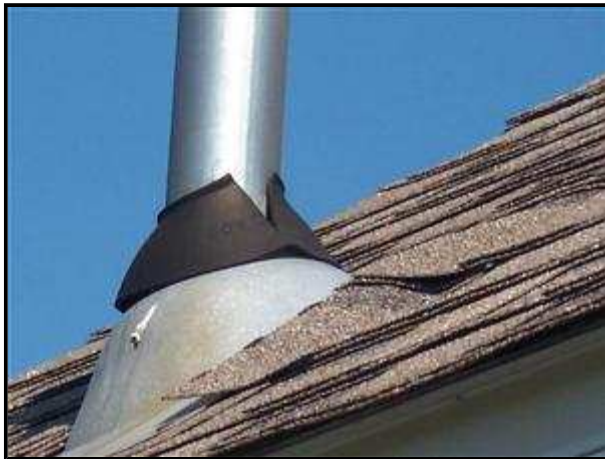
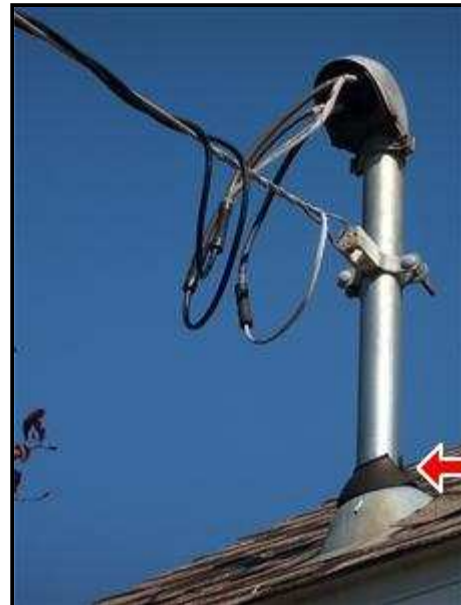
1.2 Picture 1

Roof penetration boot has failed (cracked or come loose). This condition can cause leaking or rot. Suggest a qualified repair person repair or replace penetration seal.

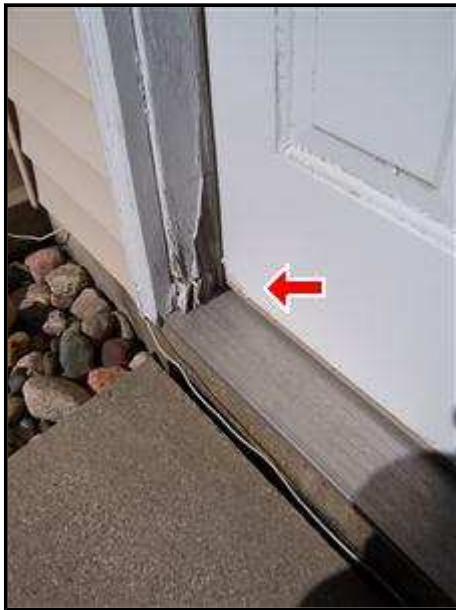
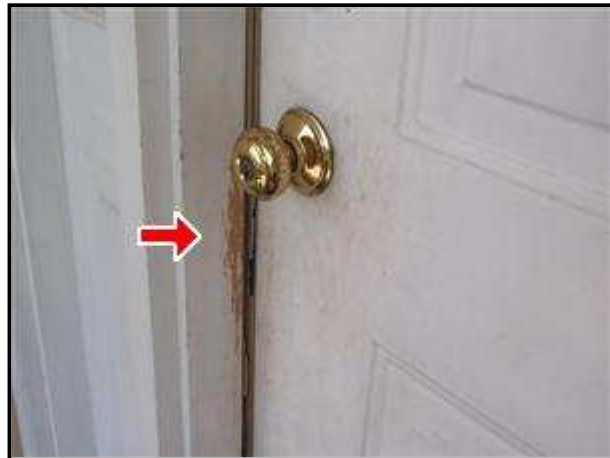
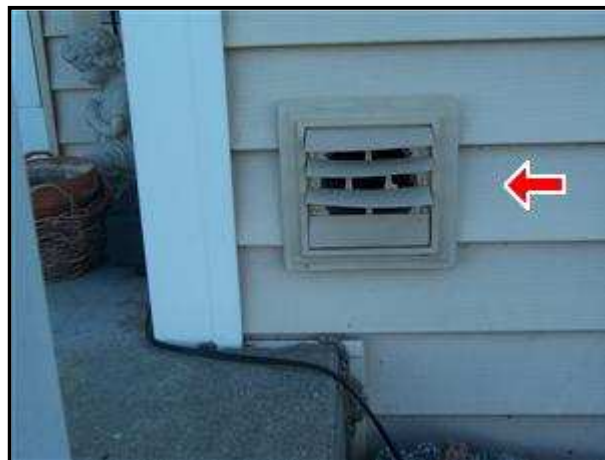
2.1 Picture 1

The rear entry door to garage has deterioration at lower frame. This should be repaired or replaced to prevent further deterioration and rot.

Seal at front door is deteriorating and needs repair or replacement.

Dryer vent at exterior of home is stuck open. This can allow vermin and debris to accumulate in dryer vent. This potentially can clog vent causing an unsafe condition.
